Different technical modifications and updatings on amber 66 – 83

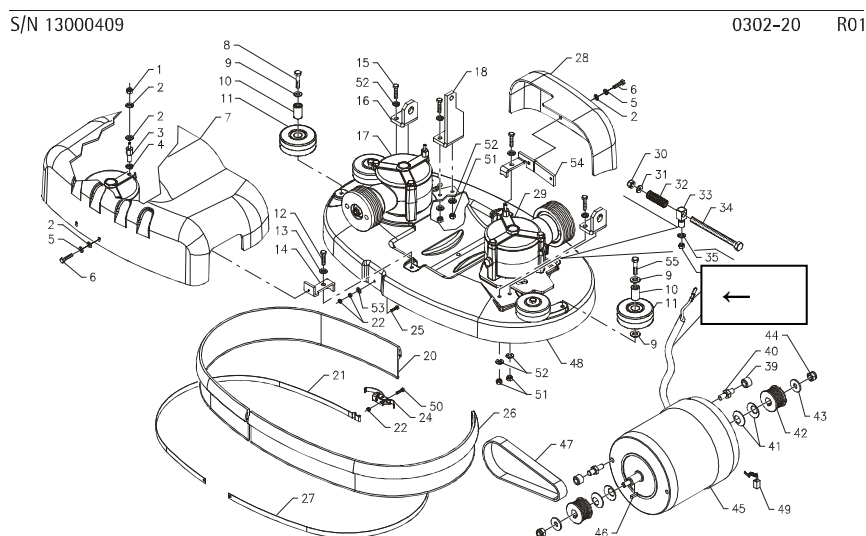
→ Starting from serial number: 13000409 dated 23/01/13 – table 0302-20 R01, pos. 11
 The brushes base 48503010 has been provided with a seat to permit the assembly of the bumper wheels also on the left side. Because of different requests from our customers, we introduce this assembly as standard.
 This modification can be applied on machines produced after 2008.

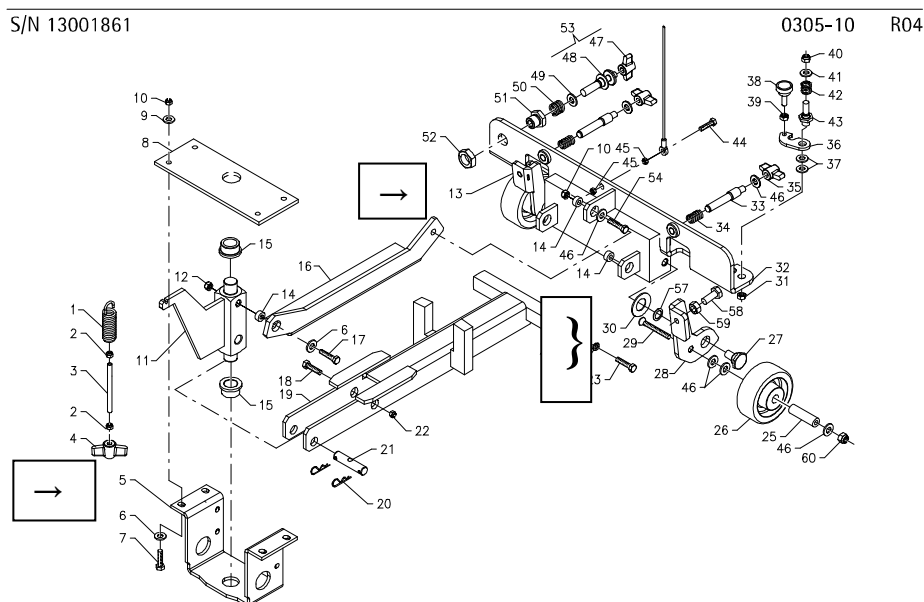
We have had some problems concerning the adjustment, because it was positioned at the limit of the screw, furthermore lifting the squeegee, the supports were not sufficiently blocked and fell down. New supports (pos. 13 and 28) have been assembled that permit a greater adjustment and that have a mechanical limit stop that prevents the wheels to fall down onto the floor. We have modified also the wheel support pin (pos. 27) to improve the fixing to the squeegee support.

Because of lateral hits of the squeegee, its arm joint (pos. 5) got deformed. We have added some lateral reinforcement ribs. The support is interchangeable with the previous one.

The squeegee adjustment results to be difficult because you work next to the limit stop. We have modified the wheel supports (pos. 13 and 28) moving the fixing hole of the wheel. You obtain in this way both a greater adjustment precision and the possibility to adjust the different squeegee types in a range that is not near to the limit. The new supports are perfectly interchangeable with the previous ones.

The new supports are interchangeable with the previous ones adding the bolts as per revised table.

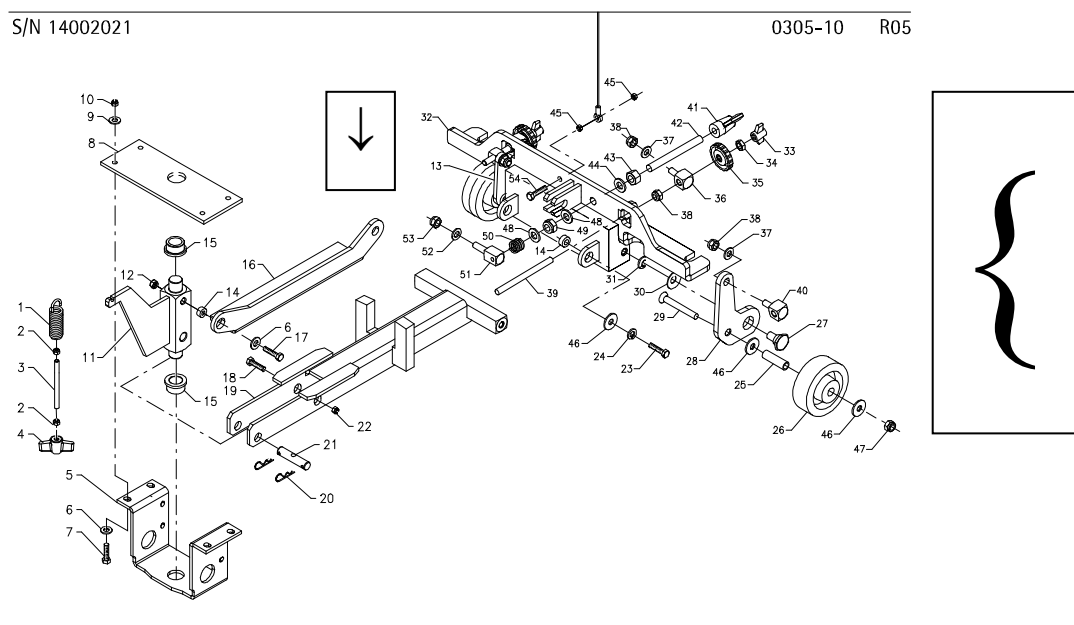
→ Starting from serial number: 14002021 dated 26/05/14 – table 0305-10 R05

The complete squeegee coupling will be replaced with a new one, because the adjustment with this new system is much more solid also in presence of heavy impacts. Consequently the adjustment system has been modified and therefore a new coupling and new wheel supports are needed. The adjustment will not be anymore by simple leaning onto the support but the new system will be equipped with a threaded tie rod and an adjuster. The new system may be applied integrally also on already produced machines.

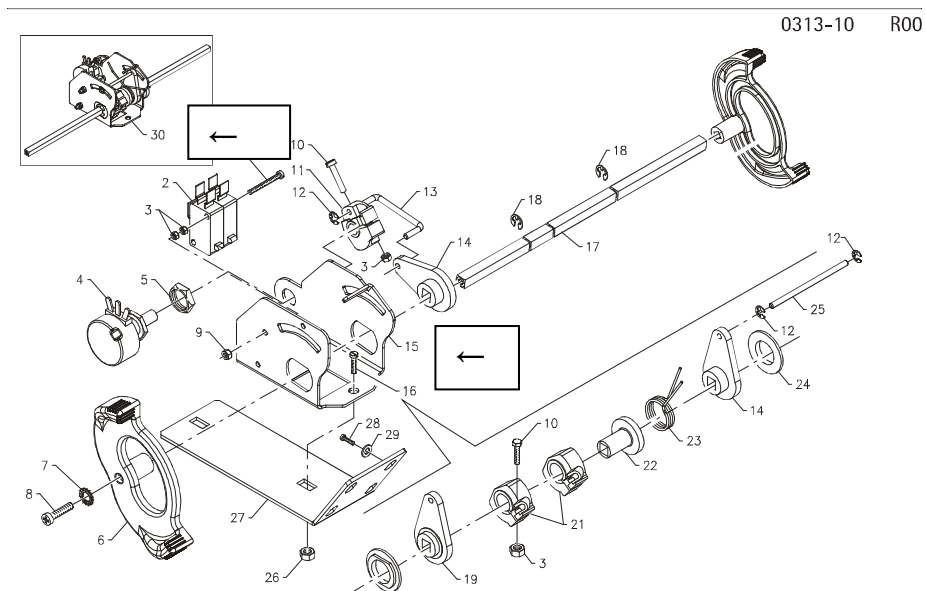
We have updated table 0313-10 R00 by adding the complete drive control (pos. 30) and we have modified the drawing of the drive control support (pos. 15).
